Complications and treatment errors in implant positioning in the aesthetic zone: Diagnosis and possible solutions

Stephen T. Chen¹ | Daniel Buser^{2,3} | Anton Sculean⁴

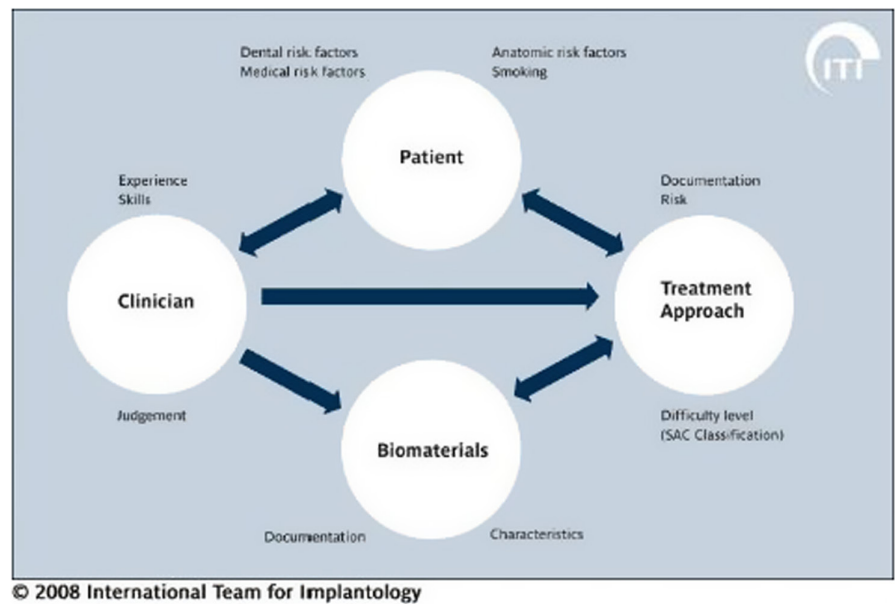
FIGURE 1 The four factors related to implant complications: the patient, the biomaterials used, the treatment approach, and the clinician. (Image from ITI Treatment Guide Vol. 3, *Implant Placement in Post-Extraction Sites*, 1st Edition, 2008 [p. 18, Figure 1] and *The SAC Classification in Implant Dentistry*, 1st Edition, 2022 [p. 10, Figure 2] used with permission from the International Team for Implantology and Quintessenz Verlags-GmbH). SAC, Straightforward, Advanced, Complex

With this increase in the number of patients receiving implants, there will be an inevitable rise in complications. Implant complications are related to four factors: the patient, the biomaterials used, the treatment approach, and the clinicians involved (Figure 1).⁴ The

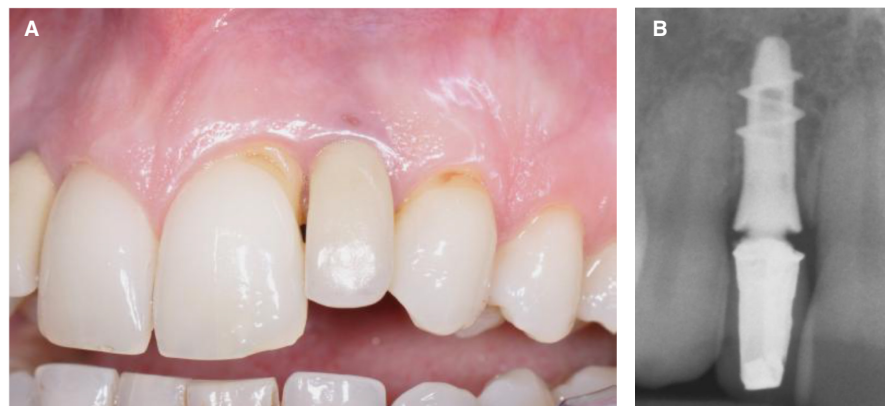
FIGURE 4 A, The papilla between the maxillary left central incisor and the lateral incisor implant has reduced in height. In addition, there has been recession of the gingiva on the distal and disto-facial aspect of the central incisor. B, The radiograph shows the proximity of the implant to the maxillary left central incisor. The peak of bone on the distal aspect of the tooth has receded

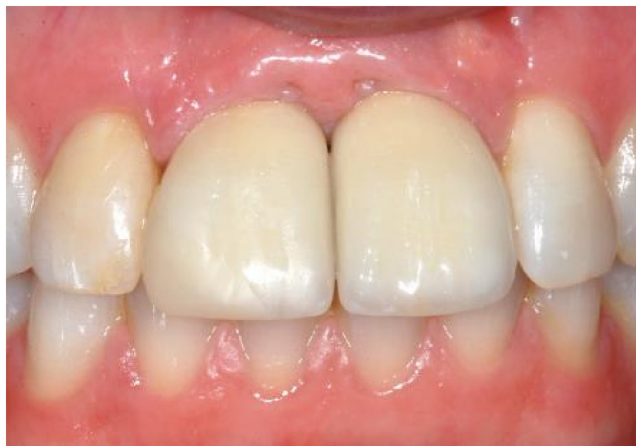
FIGURE 8 Two implants replacing maxillary central incisors have been placed too close together. As a consequence, the emergence profile of the individual crowns appears unnatural. The zenith of the mucosal margins are mesial rather than distal to the midline of each crown because of the malposition of the implants

The aesthetic outcomes with two adjacent implants placed close together may also compromise the emergence profile and outline of the mucosal margin (Figure 8).

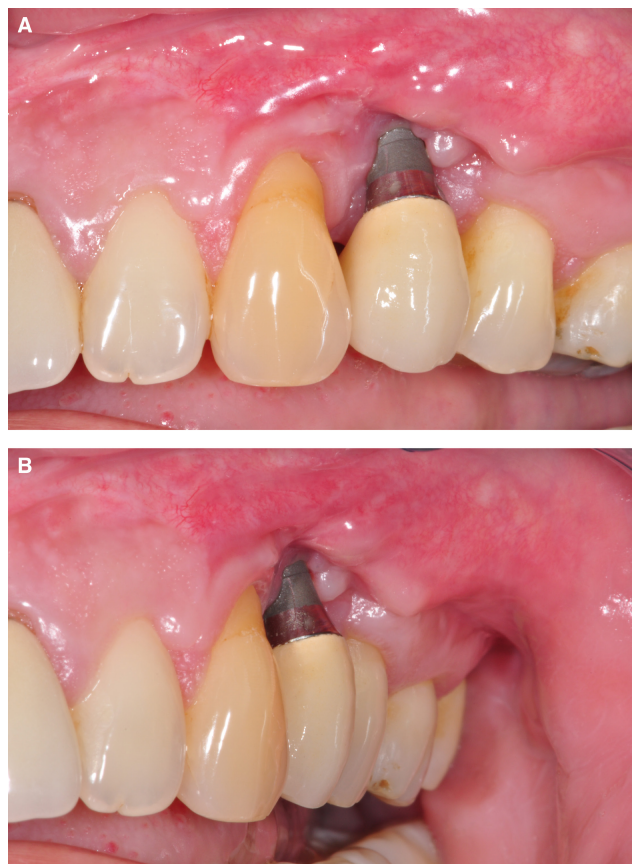
FIGURE 9 A and B, The implant in the maxillary first premolar site has been placed with the shoulder too far coronally. In addition, the implant has been placed with a slight facial malposition. The result is recession of the peri-implant mucosa and an aesthetic disaster

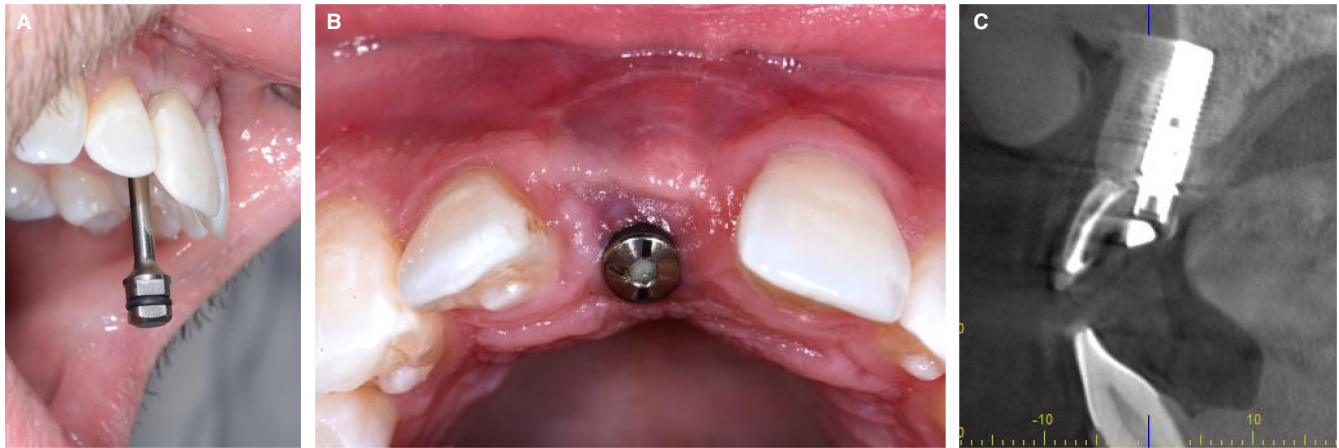
FIGURE 12 A, This implant in the upper right maxillary central incisor site has been placed in a palatal malposition. B, Following removal of the provisional crown, the palatal malposition can be observed clinically. There is also lack of tissue volume on the facial aspect. C, The CBCT scan confirmed the palatal malposition of the implant in relation to the axis of the provisional crown. Axially, the implant has also been tilted too far to the palatal side. CBCT, cone beam computed tomography

An implant may be placed too far palatally because of preexisting bone loss. This is a relatively uncommon complication. In the presence of lack of tissue volume of the facial aspect, a palatal implant malposition can lead to significantly adverse aesthetic outcomes (Figure 12A-C). If, however, the palatal malposition occurs with adequate facial contour of the ridge, it may be difficult to obtain a proper emergence profile in the final crown because of the thickness of the facial soft tissues. For this reason, ridge lap designs are often used to compensate for the palatal positioning.

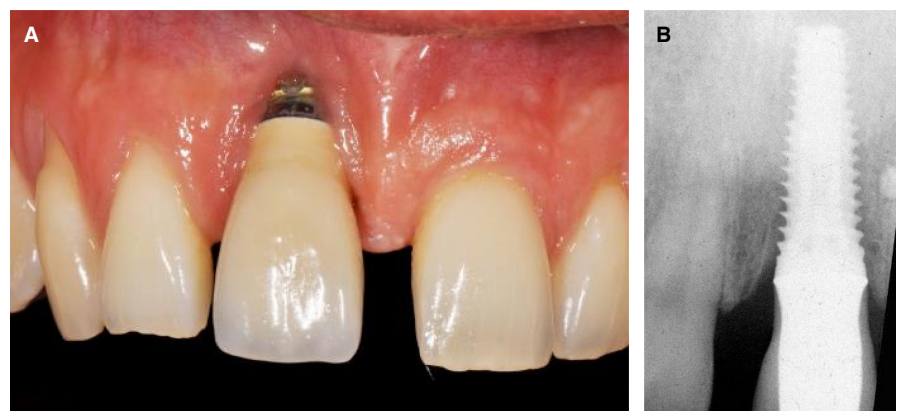
FIGURE 15 A, An implant with a shoulder diameter of 6 mm has been placed in the maxillary right central incisor site. The oversized implant has resulted in a facial malposition of the implant, and subsequent recession of the midfacial mucosa. B, The corresponding periapical radiograph of the implant

Another cause for a facial malposition is the insertion of an oversized implant, as was often recommended in the late 1990s. The large diameter (≥ 6 mm) results in a facial malposition (Figure 15A,B). Implants that are facially malpositioned are strongly associated with mucosal recession. Two studies calculated the odds ratios of mucosal recession at facially positioned implants compared with correctly placed implants as 14.7 and 17.2, respectively.^{8,22} Facial malposition is often encountered with immediate implant placement.^{23,24} The osteotomy is usually prepared in the apico-palatal region of the socket of an upper anterior tooth. When the implant is inserted, the dense cortical bone of the palatal socket wall can cause the implant to “move” slightly towards the facial side. The axis of the implant may also divert more towards the facial side. It has been shown that a small deviation of about 1 mm to the facial side of the socket is sufficient to increase the risk of soft tissue recession.²⁵ Axial malposition to the facial side is often seen in sites with developmentally missing teeth. Lack of development of the alveolar process routinely results in a significant facial concavity in the midfacial region of the alveolar

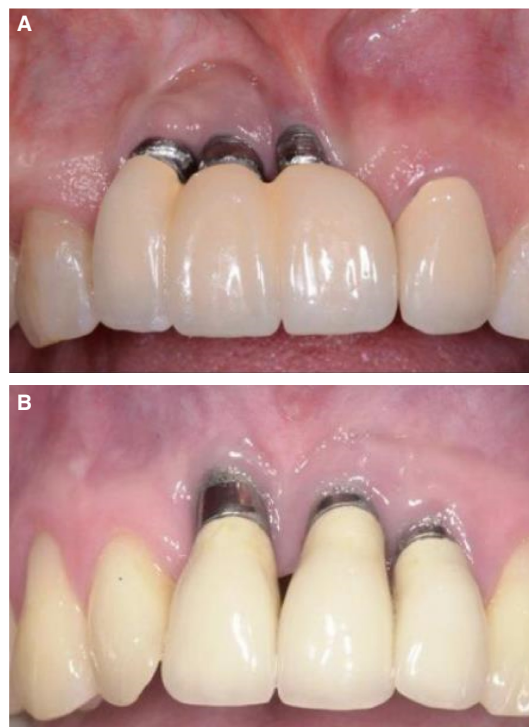
FIGURE 17 A, Because of insufficient mesiodistal space, three implants have been placed that are too close together. B, In this case, the three adjacent implants have been correctly separated. To increase the space required to accommodate the implants, they have been facially positioned and/or axially inclined to the facial aspect

Multiple adjacent implants in extended edentulous spaces can also lead to positional errors and aesthetic complications. This complication arises when the clinician has either prescribed too many implants for the available space, or has adopted the treatment philosophy to place one implant for every missing tooth. When multiple adjacent teeth in the anterior maxilla are extracted, the alveolar ridge resorbs from the facial side, resulting in a flattening of the ridge. The mesiodistal dimension of the flattened ridge is less than the original mesiodistal dimension prior to tooth extraction (Figure 16). If multiple adjacent implants are placed, there is a risk that the implants may be placed too close together (Figure 17A). To avoid implant proximity, the implants may instead be facially positioned and/or axially inclined to the facial side (Figure 17B). In either scenario, the result is usually an unaesthetic soft tissue outcome.

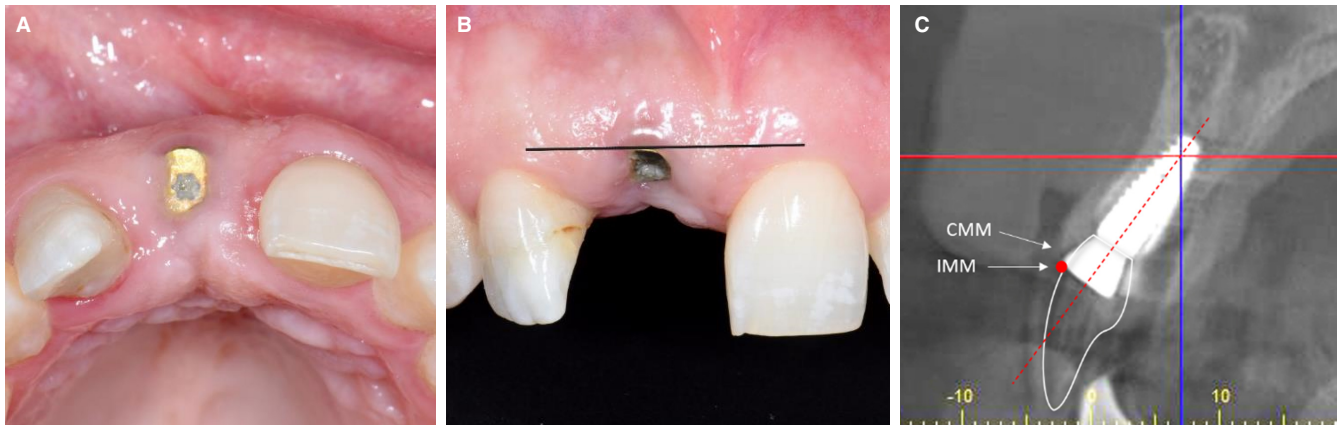
FIGURE 19 A, The implant in the maxillary right central incisor has been placed in a facial malposition. The facial aspect of the healing abutment is at the limit of the curvature of the arch at the level of the gingival margin. B, From the facial aspect, the mucosal margin at the implant is approximately 1.5 mm apical to that of the contralateral central incisor. C, The corresponding sagittal view of the CBCT scan clearly demonstrates the facial and axial malposition of the implant. The central axis of the implant in (red dotted line) shows the implant emerging facial to the incisal edge of the anticipated restoration (white outline of the crown). The red dot marks the IMM located 1.5 mm coronal to the CMM. The clinician then has to determine whether a crown, abutment, and minimum 1 mm soft tissue thickness can be accommodated at the level of the red dot without extending facially to it. In this case, it was determined that the facial and axial malposition was too severe, and the decision was therefore made to remove and replace the implant. CBCT, cone beam computed tomography; CMM, current mucosal margin; IMM, ideal midfacial mucosal margin

estimated in the parasagittal plane. For the soft tissue graft to be successful, there needs to be sufficient space within the curvature of the arch to accommodate the crown, abutment, and at least 1 mm thickness of the mucosa. This is illustrated in Figure 19. This

patient was referred to manage recession of the mucosa that was observed following connection of a healing abutment and prior to construction of the definitive crown. From an occlusal view, it could be seen that the facial edge of the healing abutment already extended facial to the curvature of the dental arch at the level of the gingival margins of adjacent teeth (Figure 19A). A frontal view demonstrated that the mucosal margin had already receded approximately 1.5 mm apical to that of the gingival margin of the contralateral central incisor (Figure 19B). The corresponding cone beam computed tomography scan illustrates that, at the level of the ideal midfacial mucosal margin position, there would be insufficient orofacial space to accommodate the crown, abutment, and 1 mm of soft tissue thickness (Figure 19C). The outcome of a connective tissue graft to correct the recession would therefore be unpredictable.
